A SYSTEMATIC APPROACH TO CASE RECERTIFICATION

Dresser-Rand Turbo Products Division

Case History

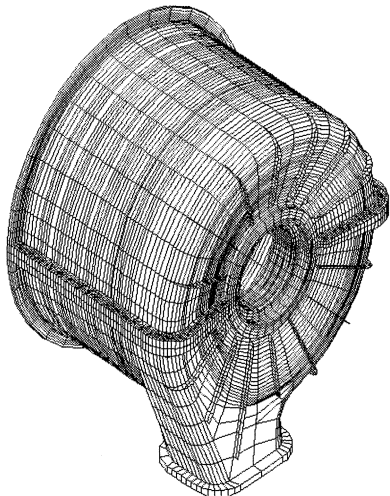
Only the discharge end was modelled. This model, illustrated in Figure 1, contains over 26,000 nodes and over 18,000 brick type (eight noded) elements. Beam elements, each with a 60,000 psi simulated preload, were used to represent the bolts connecting the upper and lower halves at the horizontal flanges.

Figure 1. FEA Model of Discharge End of MTA 5124 Casing.

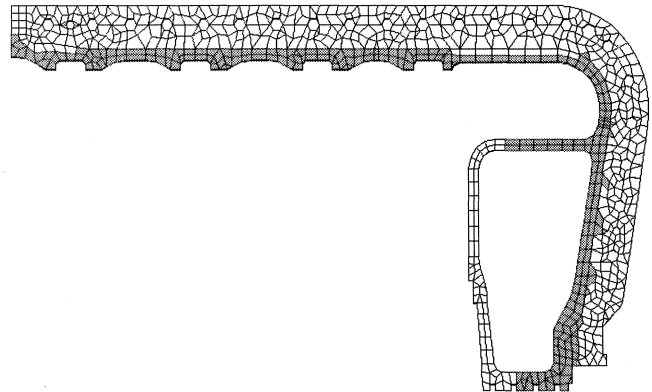
In general, the highest stresses occurred on the discharge end on the inside near the transition from the cylindrical to the end section. The calculated separation at the horizontal split resulting from the 72 psig pressure is shown in Figures 2 and 3. The darker shading shows areas of expected separation. These Figures show that small areas of leakage are possible at the casing discharge end.

Figure 2. Separation of Casing at Horizontal Split Line—Right Side as Viewed From Discharge End. Darker shading show areas of separation.

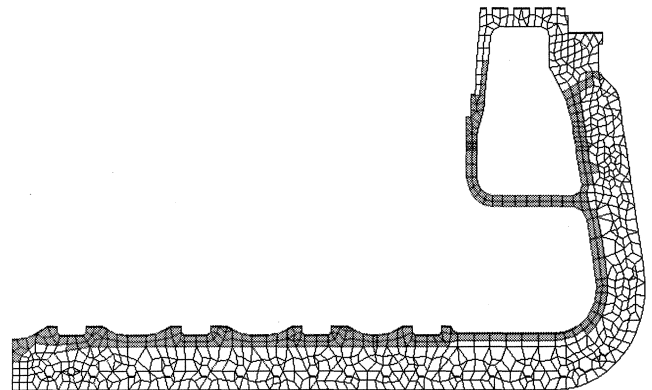
Figure 3. Separation of Casing at Split Line—Left Side as Viewed From Discharge End. Darker shading show areas of separation.

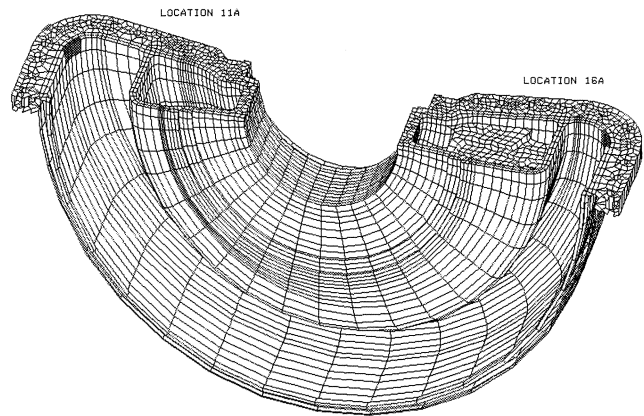
The seven locations at which strain gauges were placed are shown in Figures 4, 5, 6, and 7. Five of the seven locations were on the inside of the discharge case. Strain rosettes were placed at these five locations to provide 2-D Von Mises stresses in the plane of the surfaces that they were bonded to. Locations 1a and 6a, shown in Figure 4, are on opposite sides of the lower case, at the transition from the cylindrical to the end section (i.e., the most highly stressed portions of the lower case), at the horizontal split plane flange. Location 3a, also shown in Figure 4, is inside of the lower discharge case, at the nozzle to casing body transition. This is the most severely stressed corner of the nozzle. Locations 11a and 16a, shown in Figure 5, are in analogous positions to Locations 1a and 6a inside of the upper casing, again at the horizontal split plane flange.

Figure 5. Strain Gauge Locations 11a and 16a on Upper Discharge Case.

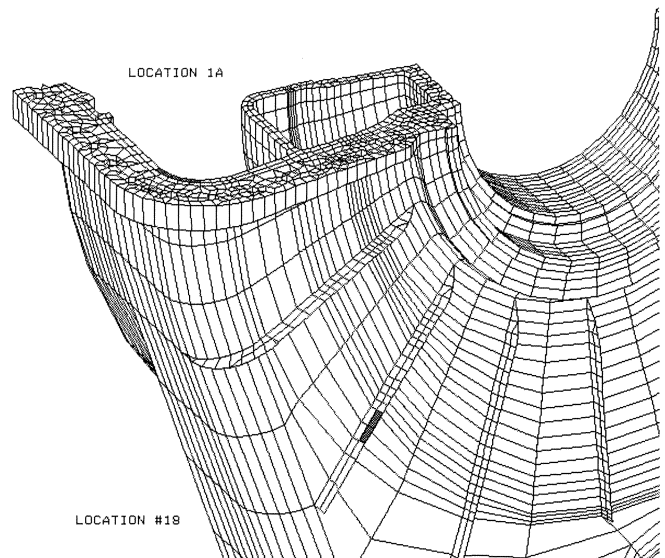
The sixth location, shown in Figure 6, is a stiffening rib location (identified as Location 18), which extends alongside the outside of

Figure 6. Strain Gauge Location 18: Stiffening, Rib Lower Discharge Case.

the nozzle. The finite element analysis identified this rib as the most severely stressed rib due to its dual role in a) stiffening the end of the case from outward expansion and b) acting as a load path for nozzle loads. A uniaxial strain gauge was bonded there oriented to measure "length direction" strains.

The large difference in results for gauge 18, which was on a casing rib, were suspected to be caused by the weight of the liquid which had not been included in the analysis. Considering the possible contributors to stress differences mentioned previously, and the general difficulties in comparing analysis to test results, the above correlation was considered to be good.

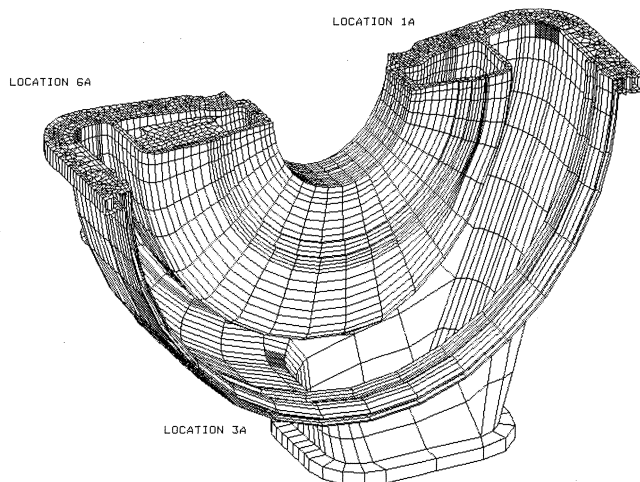
Figure 4. Strain Gauge Locations 1a, 3a, and 6a on Lower Discharge Case.

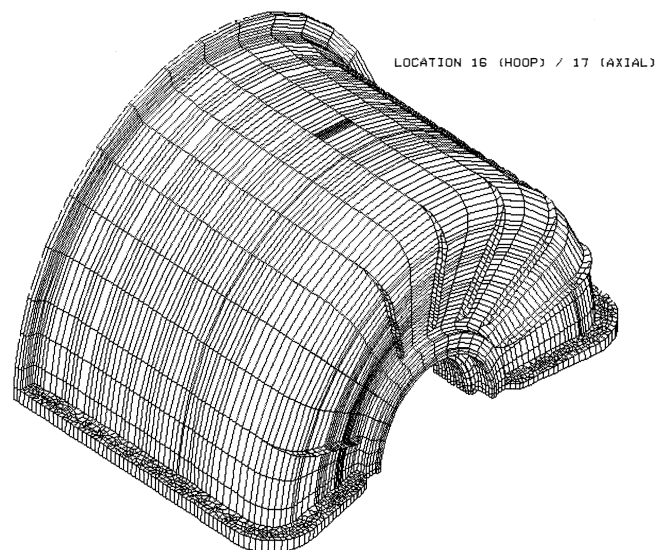
Figure 7. Strain Gauge Location 16/17: Calibration Point, Upper Discharge Case.

A seventh, non-stress critical, calibration point was also selected. Location 16/17 was selected for this purpose and is shown in Figure 7. At this location, two uniaxial strain gauges were placed and oriented to measure handbook predictable hoop/axial direction (cylindrical shell type) case stresses. Location 16/17 is 44.5 in from the vertical split at the top of the casing.

This comparison is shown in Table 1. Gauge 17 had failed, explaining the poor correlation of results at this gauge.
